EXHIBIT 8

May 9, 2019

Re: *Susman, et al. v. The Goodyear Tire & Rubber Company*

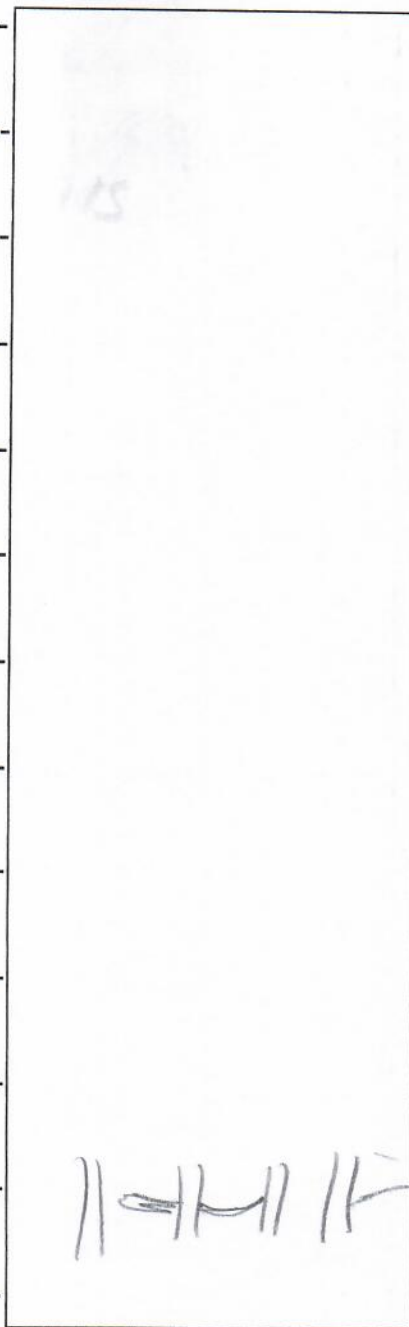
LF COMPANION

11:00 Visible
Cosmetic openings
of leading edge
of tread surface

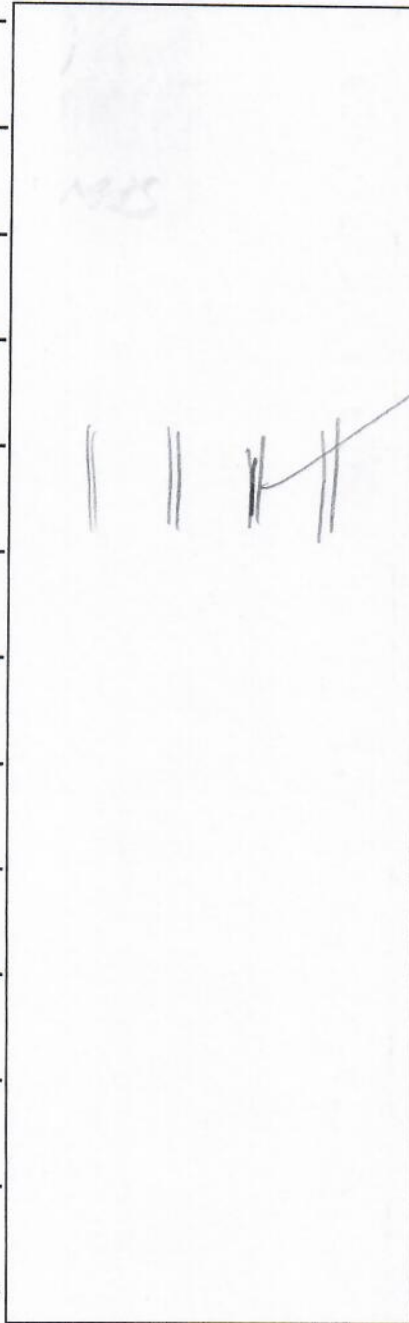
LR COMPANION

4:00 - 4:30
 ~ 3" cut in bottom
 of OSS intermedial
 Tread Groove
